# BLAKES LAVAC TAYLORS

## Owners Handbook

**BLAKES** marine toilets

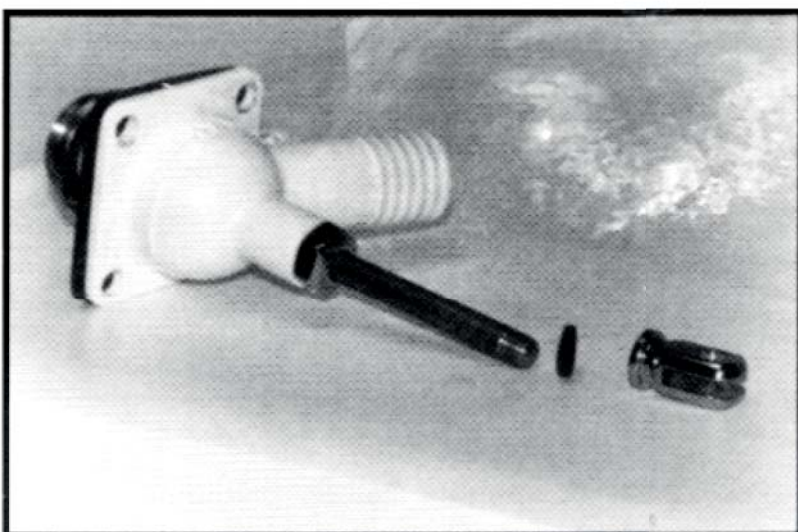
To access the lip seal (78LS) in the the pump top (76ALS) or gland nut (77LS) the pump top and discharge rod (39) must be separated. Hold the discharge rod (39) in a soft jaw vice to unscrew the double lug (37). Remove the leather washer (38). The discharge rod (39) can now be carefully withdrawn from the top (76ALS or 76A).

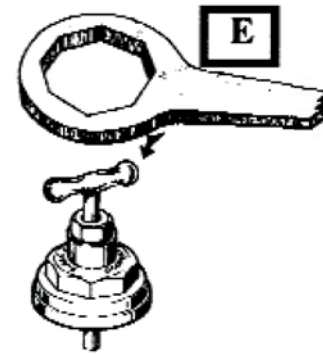
The flushing pump top has a shallow octagonal top and it is recommended that **spanner E** is used to unscrew the top.

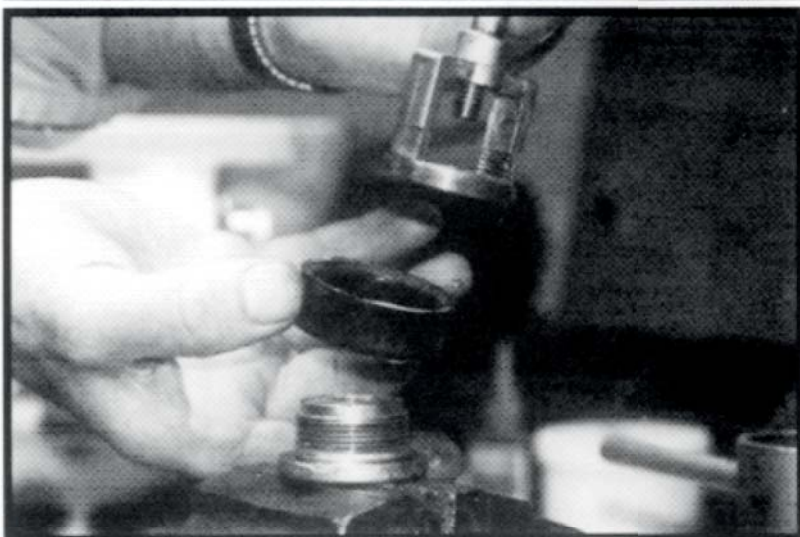
This will allow removal of the bucket washer (25 or VE25). Replace. Note: the tolerance on bucket washers is oversize to allow for any wear on the cylinder, therefore it may be necessary to take a little of the material off the outer circumference - as evenly as possible - using a file or emery paper

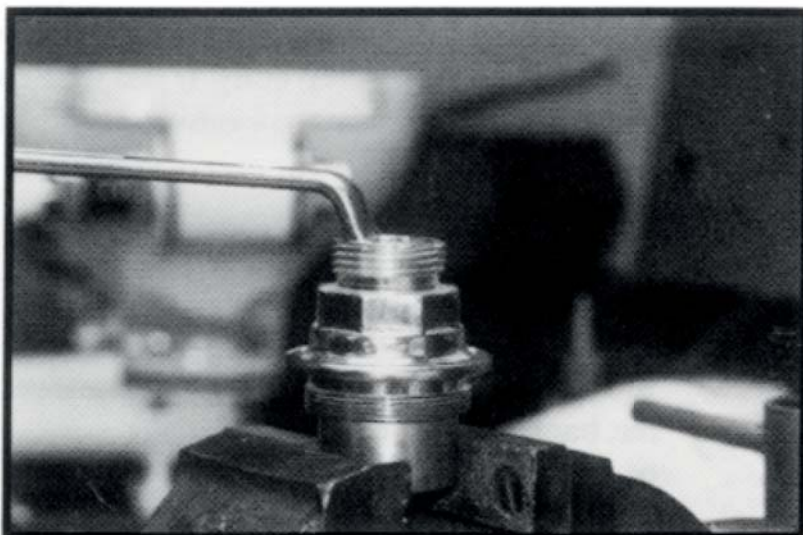
Hold the lower valve housing (28 or VE28) in a bench vice. Remove the lower valve nut to dismantle the assembly.

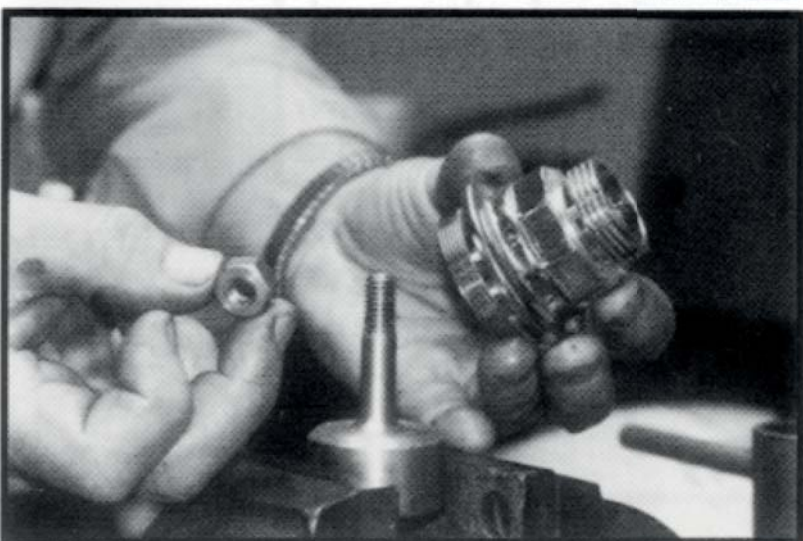
Inspection of surfaces will indicate if there is excess wear, if so replace the necessary components.
