## **WS 67 ULTRA GALLEY PUMP REPAIR INSTRUCTIONS**

### **Service Kitset: WS67/16**

# W.S. 67 *Fynspray* ULTRA GALLEY PUMP

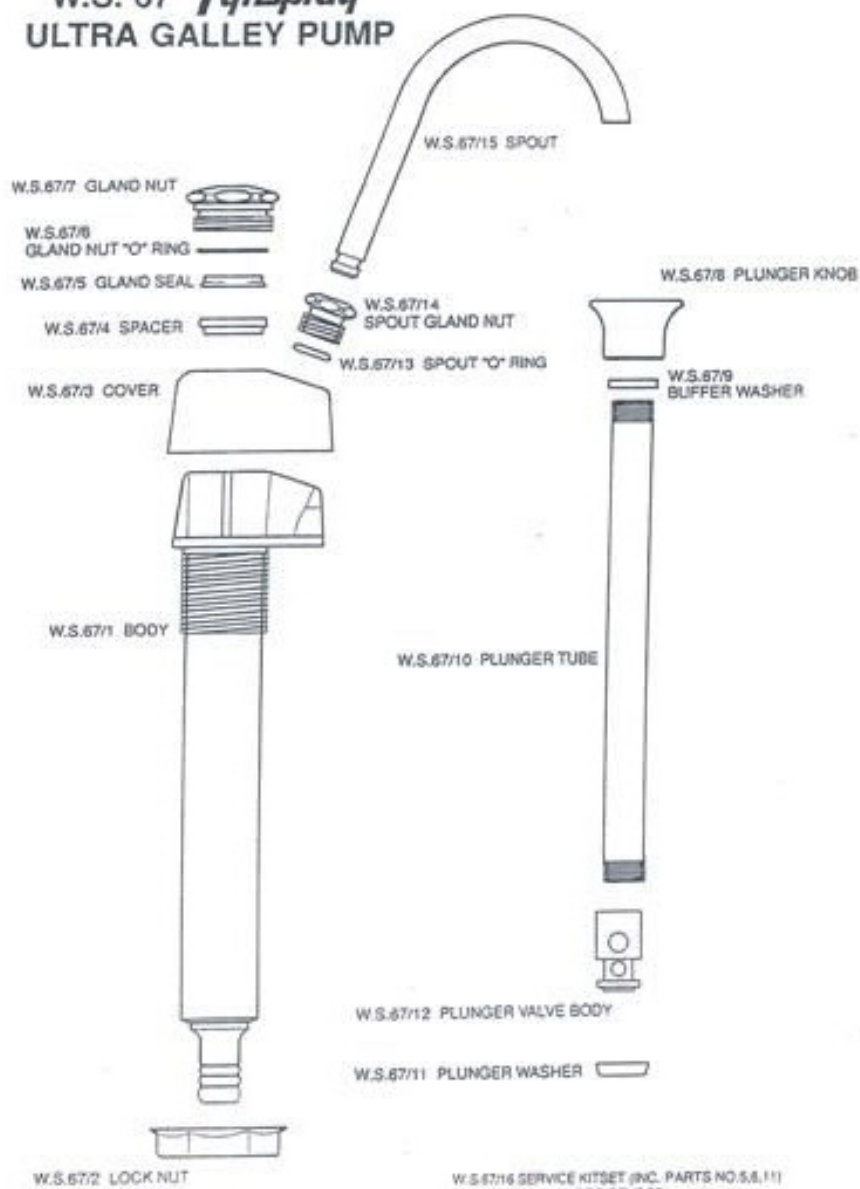
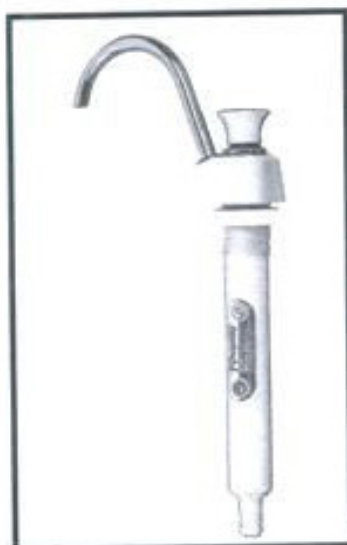
WS 67

Unscrew the gland nut (#7) which enables the complete plunger assembly to be removed. Check that the plunger washer (#11) is soft & pliable and that it is a push fit inside the pump barrel. If it is not a push fit and/or is cracked it must be replaced. When replacing, immerse the new washer in hot water (or use a little light oil). Making sure it is the correct way up, push fit from the bottom over plunger valve body. It does cover the bottom plunger valve body hole and “floats”.

Having removed the complete pump assembly (as above) unscrew the plunger valve body (#12) (earlier models unscrew the plunger knob (#8)). **DO NOT HOLD THE PLUNGER TUBE IN ANY TOOLS AS THEY MAY CAUSE DAMAGE.** When replacing or removing the gland seal onto the plunger wind it in the direction of the plunger thread so as not to damage the lip edge.

The gland nut ‘o’ ring (#6) is also included in the Service Kitset and whether replaced or not should be lubricated with a little Vaseline.

Note that both the gland nut (#7) and the spout gland nut (#14) should not be over-tightened.

Parts #5, 6, & 11 are contained in the service kitset.
