BLAKES LAVAC TAYLORS

BLAKES marine toilets

Owners Handbook

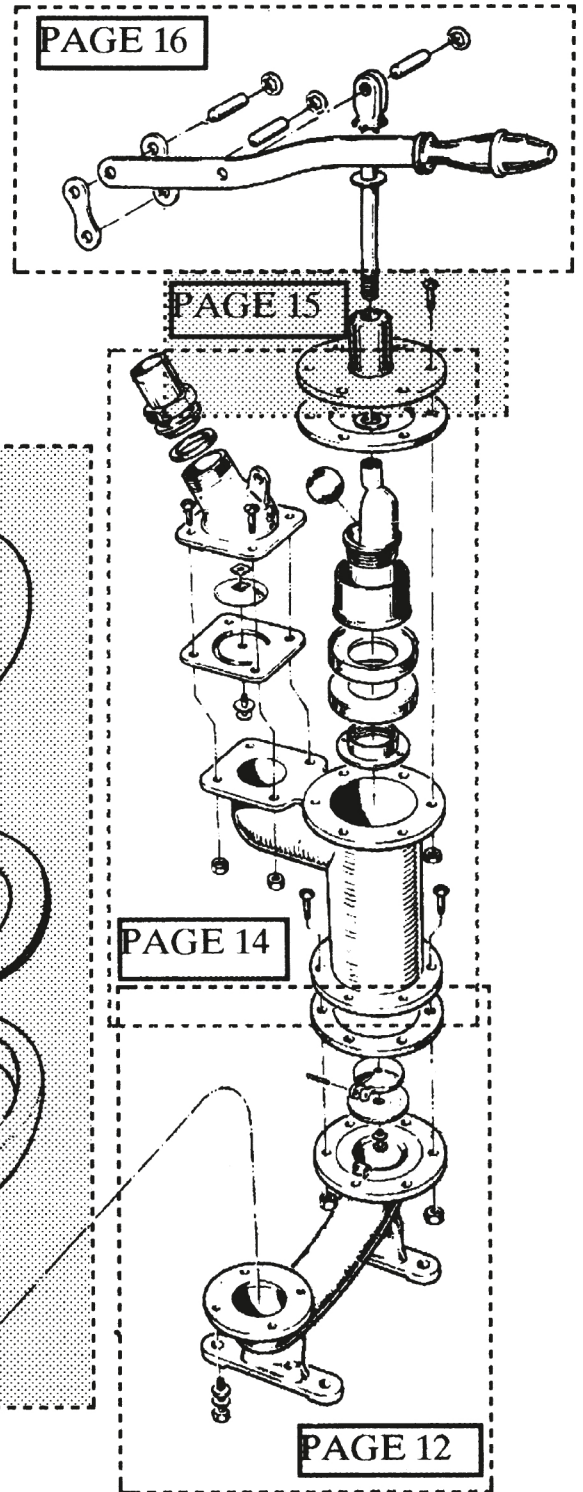
Note: The diagram on this page details the current specification Victory toilet. The old specification components are detailed on the relevant pages. Options are also detailed, some options have been discontinued and these are specified where relevant.

VICTORY MODEL

Toilet Base assembly

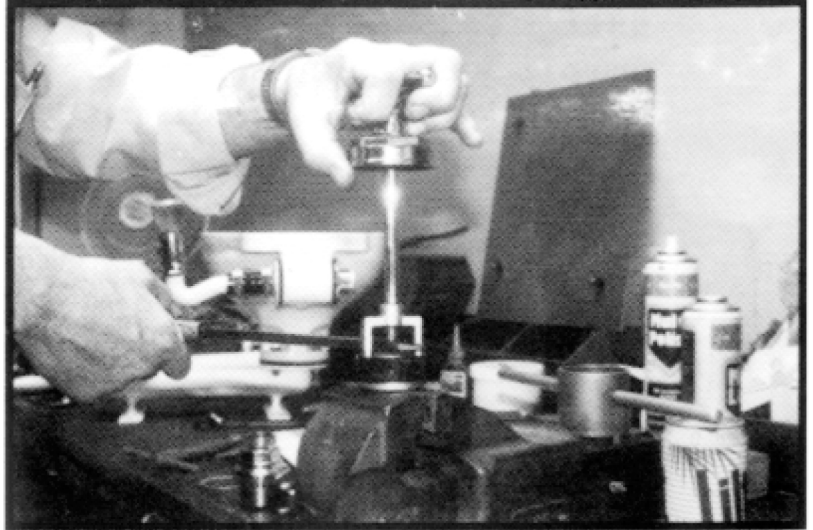
Hold the valve plug (24 or VE24) in a vice. Locate a screwdriver (or bar) through the bridge piece (23 or VE23) and unscrew from the valve plug (24 or VE24).

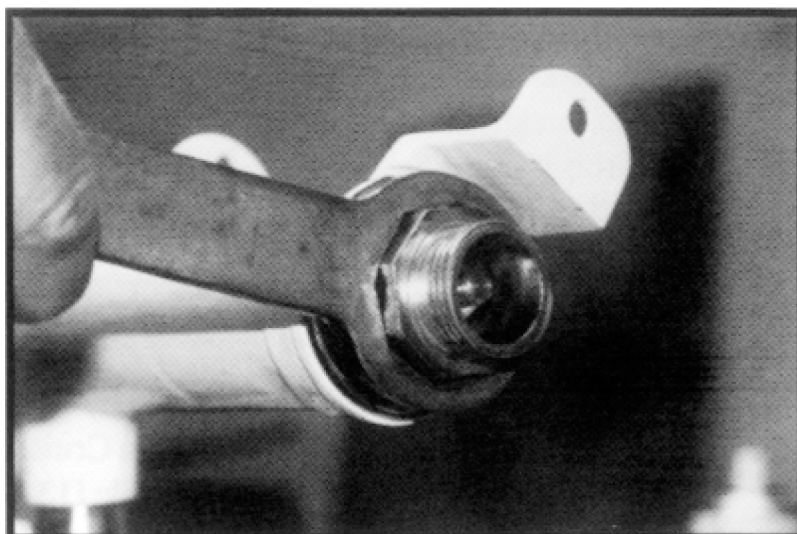
Remove the heavy valve assembly at the bottom end using spanner F.

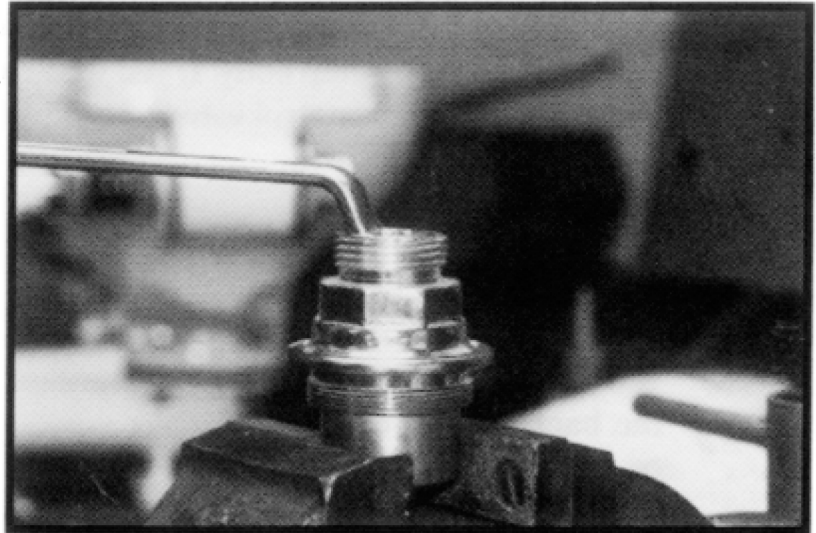
Hold the lower valve housing (28 or VE28) in a bench vice. Remove the lower valve nut to dismantle the assembly.

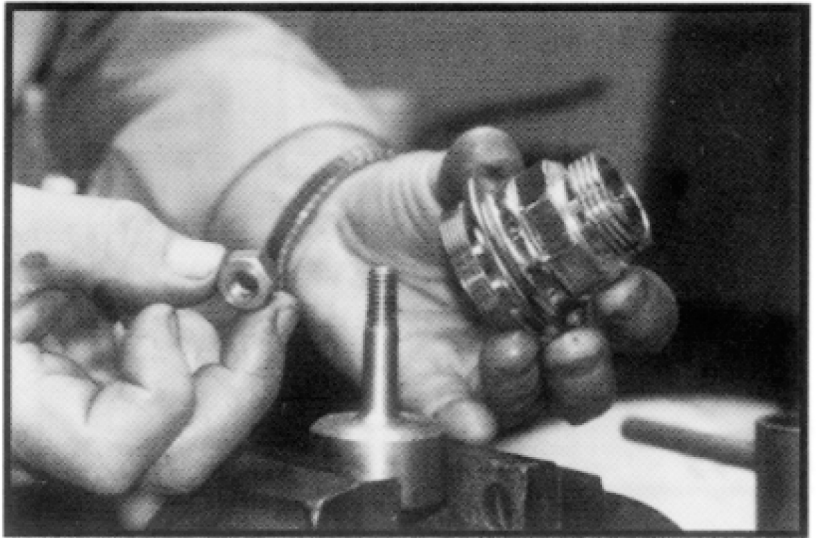
Inspection of surfaces will indicate if there is excess wear, if so replace the necessary components.
